Manhole Inspection Summary

Manhole # S33MM_020MH

Location Address: **2101 21ST ST**

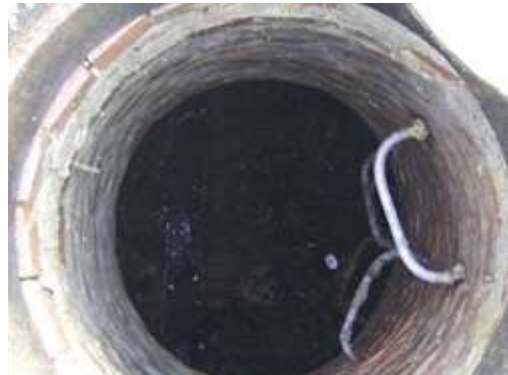
Top View

Adjustment deterioration and infiltration.
Corroded steps. Evidence of surcharge -
Bench debris. Channel debris.

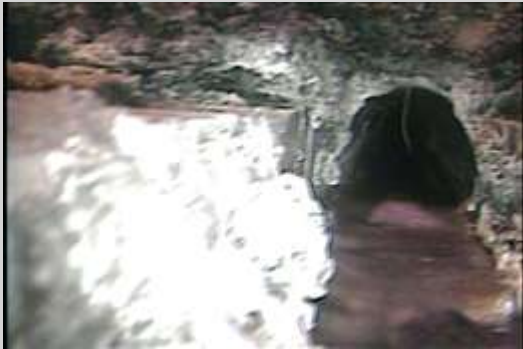
8 in. Circular Gravity Sewer Pipe Out @ 12 O'Clock

Deposits: ☐ None ☒ **Mud** ☐ Sludge ☒ **Debris** ☐ Grease

Silt Depth: **0** (in.) Deposits Extent: **Light**

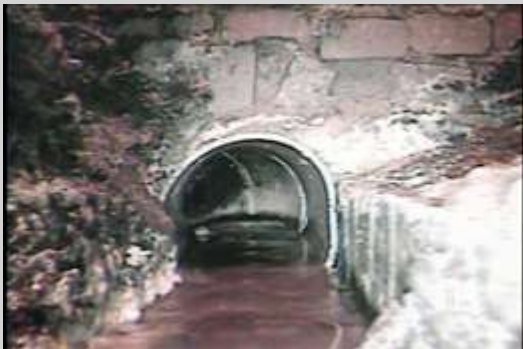
8 in. Circular Gravity Sewer Pipe In @ 6 O'Clock

Barrel deterioration and infiltration.

Deposits: ☐ None ☒ **Mud** ☐ Sludge ☒ **Debris** ☐ Grease

Silt Depth: **0** (in.) Deposits Extent: **Light**

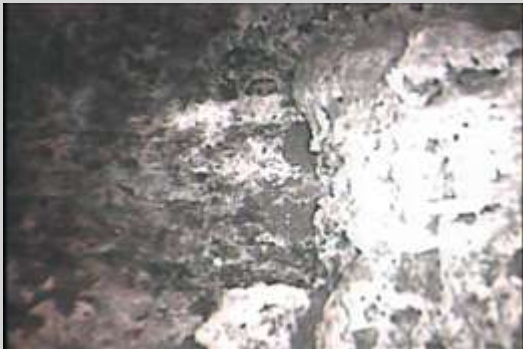
8 in. Circular Gravity Sewer
Pipe In @ 9 O'Clock

Connects To: **Stub connection / abandoned**
☐ Possible Illicit Connection
